# INTEX®

## Leaking at cover

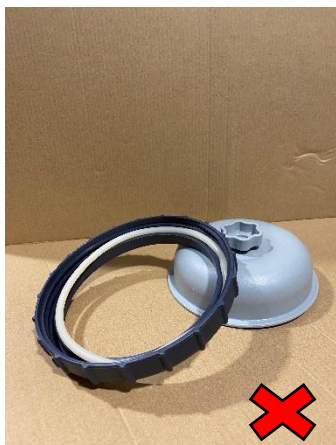
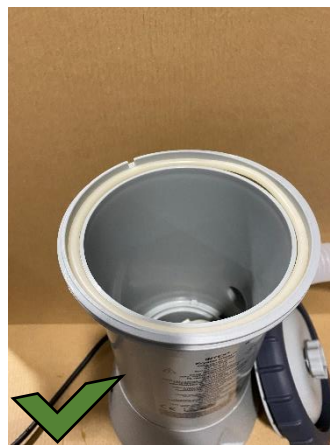
There are multiple possible causes for the leakage at the cover. The main reason is that the leakage is caused by the fact that the O-ring is not located under the lid, but in the screw ring. The O-ring should not be in the screw ring but in the housing under the cover. Due to its incorrect placement, the pump is not completely sealed off, which can result in leakage.

Below are two photos of both the correct and incorrect placement of the O-ring. Please check carefully whether it has been placed correctly, and if not, place it correctly using the step-by-step plan as mentioned above.

- Step 1:** Loosen the screw ring and remove the cover
- Step 2:** Remove the O-ring from the screw ring  
(If it does not come loose, you can tap it gently on the ground to loosen the O-ring)
- Step 3:** Place the O-ring on the ledge on the inside of the filter housing  
(where the lid used to be)
- Step 4:** Place the lid on top of the O-ring
- Step 5:** Tighten the screw ring
